Docket No. 217 – Development and Management Plan Inspection

Northeast Utilities Service Company Certificate of Environmental Compatibility and Public Need for the construction of a 345-kV electric transmission line and reconstruction of an existing 115-kV electric transmission line between Connecticut Light and Power Company's Plumtree Substation in Bethel, through the towns of Redding, Weston, and Wilton, and to the Norwalk Substation in Norwalk, Connecticut.

Date: May 17, 2006

Location: 115 kV Underground Route

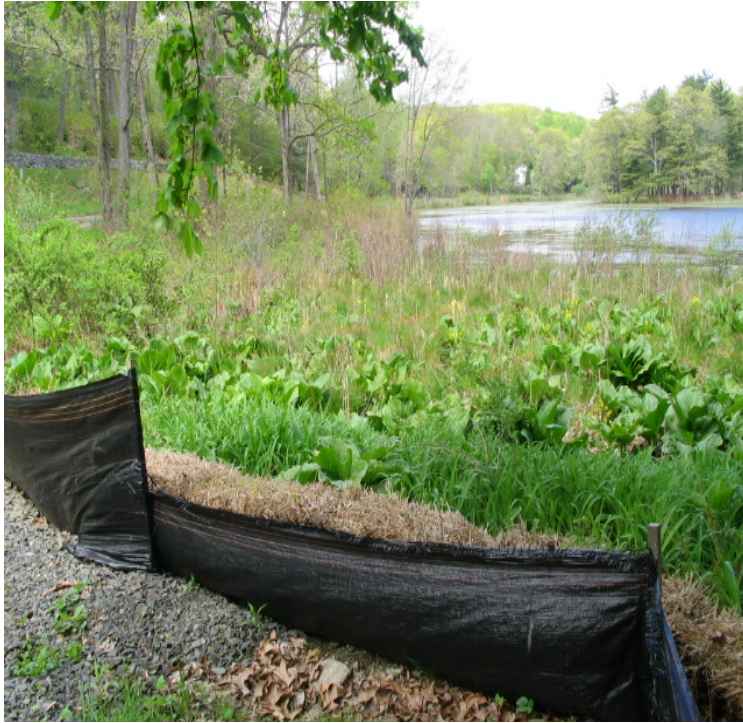
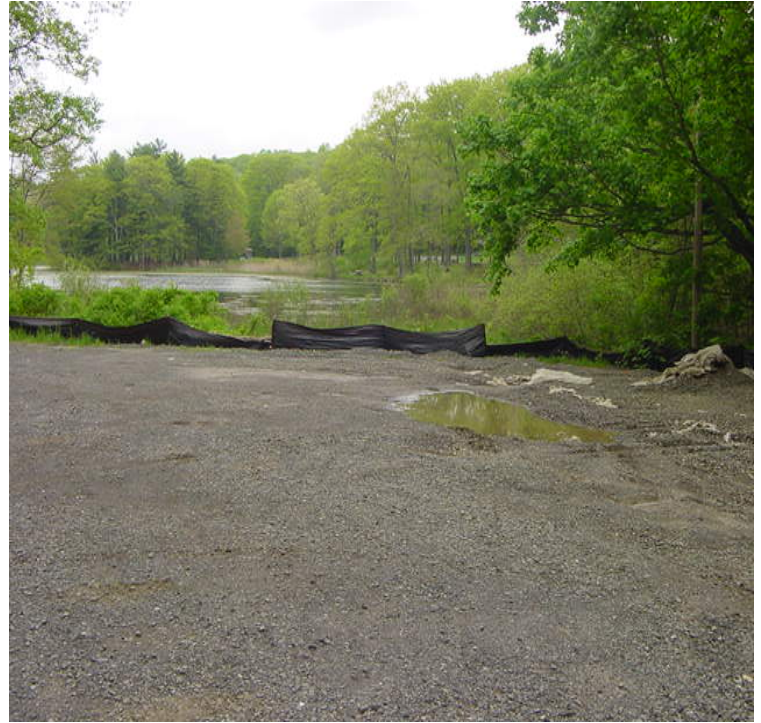
115kV (Putnam Park): Both photos show the old storage area with controls in good shape. Photo on the left shows the undisturbed adjacent wetland with good vegetative cover returning to the area with the growing season. 5/17/06

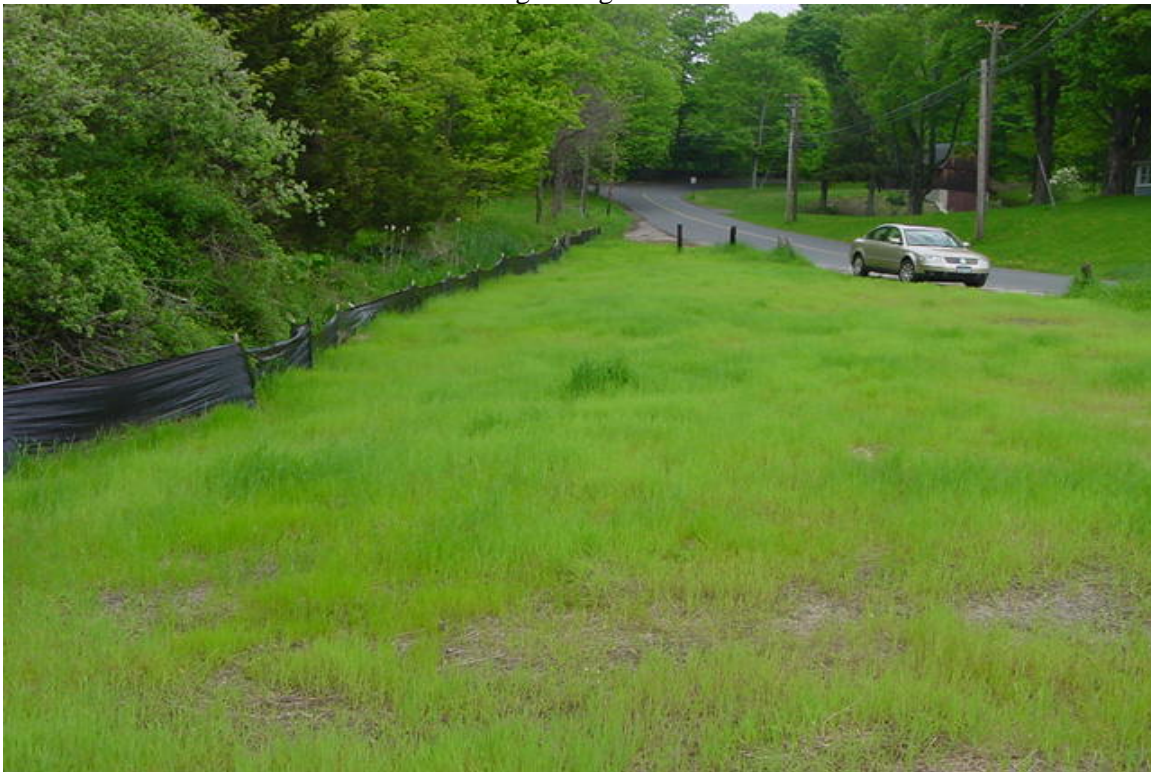
(Sunset Hill): Photo shows the strong vegetative growth returning to the area. The portion of the yard adjacent to Rt 58 is still a little patchy. 5/17/06
